**STAFF REPORT
HISTORIC AND CULTURAL LANDMARKS COMMISSION
CITY OF FORT WORTH, TEXAS**

REQUEST	Recommendation for Designation as a Historic and Cultural Landmark
APPLICANT/AGENT	John Doubleday
LOCATION	115 W 7 th Street
ZONING/ USE (S)	H – Central Business / DUDD Overlay
NEIGHBORHOOD ASSOCIATION	Individual

The owners request a recommendation to City Council to consider designating the property at 115 W 7th Street as a Historic and Cultural Landmark (HC).

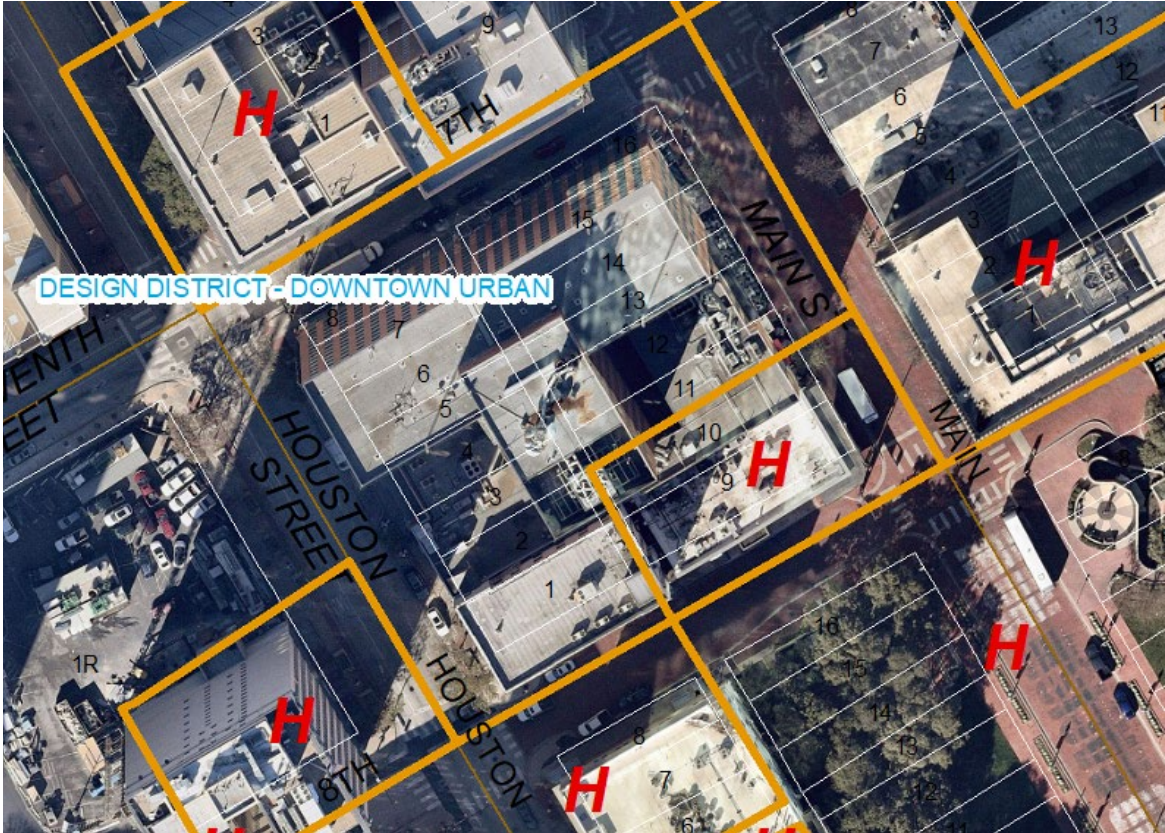
Figure 1 Aerial Image of subject property circa 2022

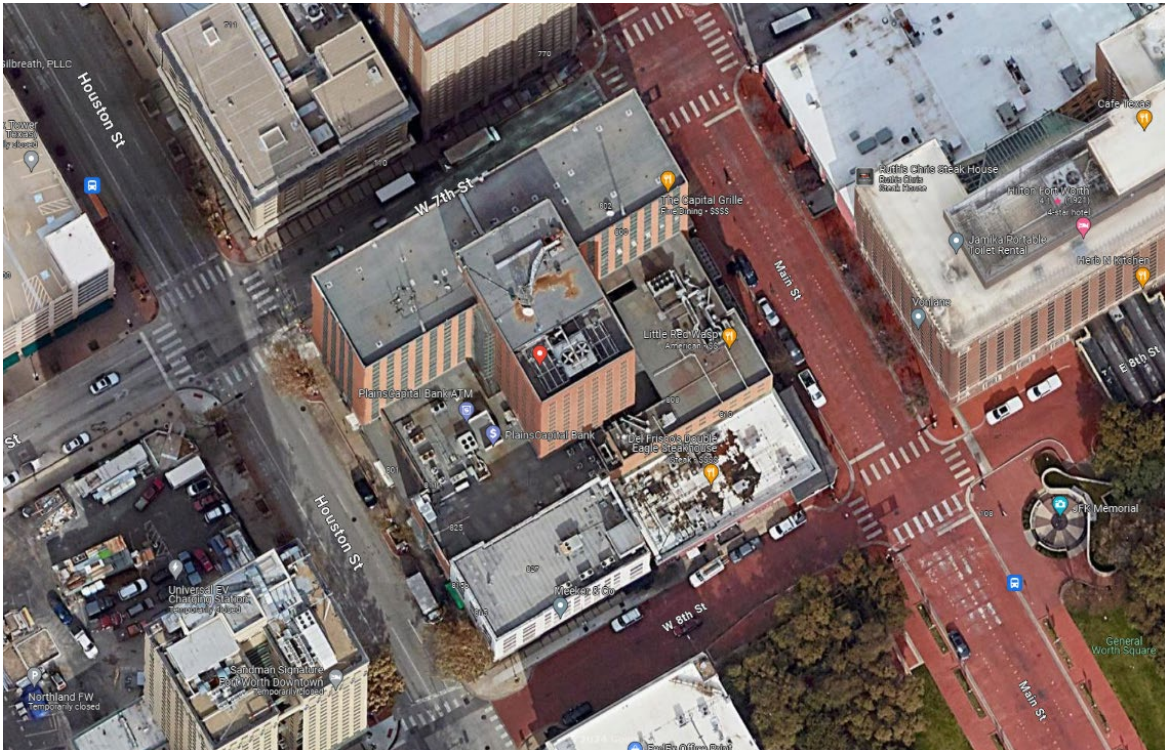
Figure 2 Google Aerial image of 115 W 7th St in 2024

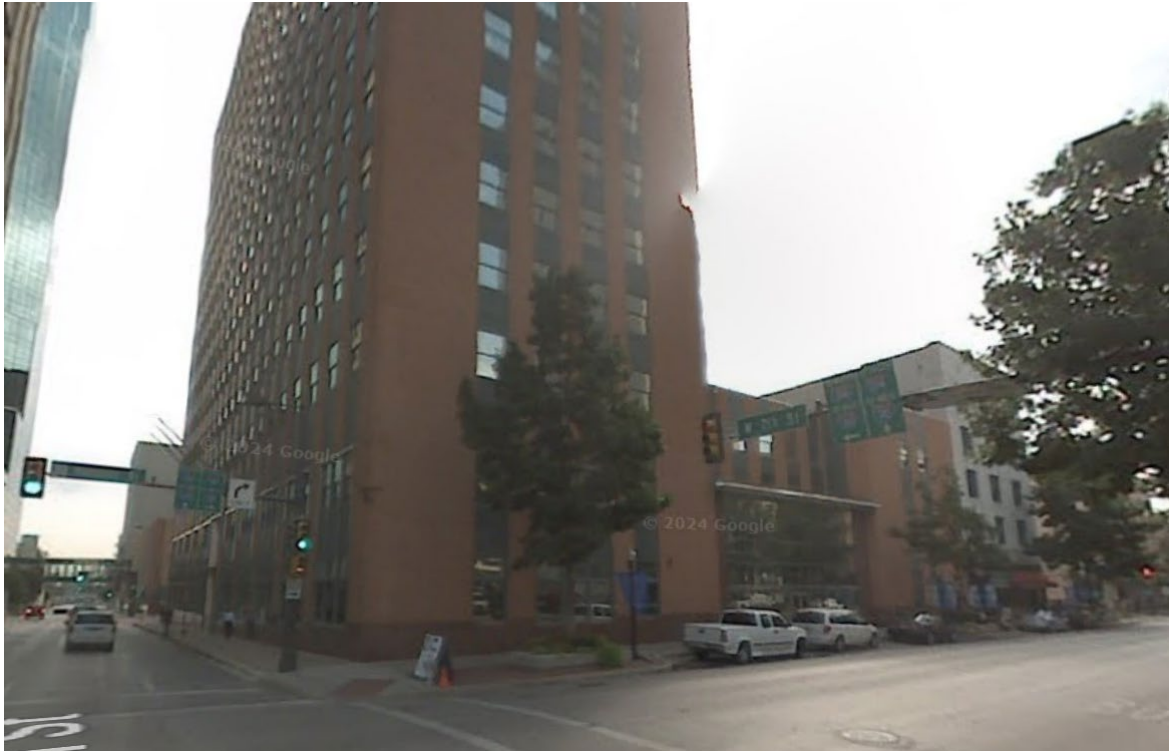
Figure 3 Google Street View of 115 W 7th St circa 2007 before the 2011 exterior renovations to the first and second floors. NWC of 7th and Houston.

4. The property's **materials** appear generally intact. It retains integrity of materials on its exterior, including its brick curtain walls and vertically aligned metal windows that are separated by Virginia greenstone spandrels. Although the exterior of the lower levels of the east, north, and west elevations have been altered with the introduction of new materials in 2011-2012, the texture and color variation between the historic rust-colored brick and greenstone spandrels remain a strong character-defining feature on the upper floors.

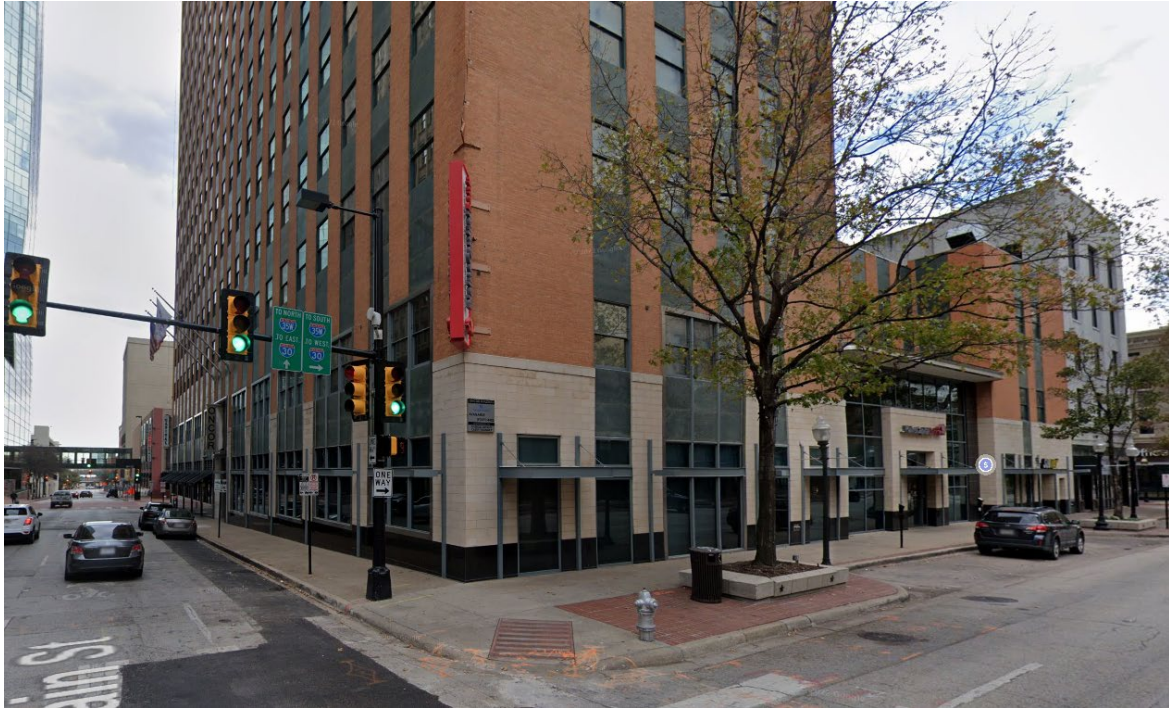
Figure 4 Google Street View of 115 W 7th St circa 2022 after the 2011 exterior renovations to the first and second floors. NWC at 7th and Houston. Note the awnings, additional storefront windows, and material changes.

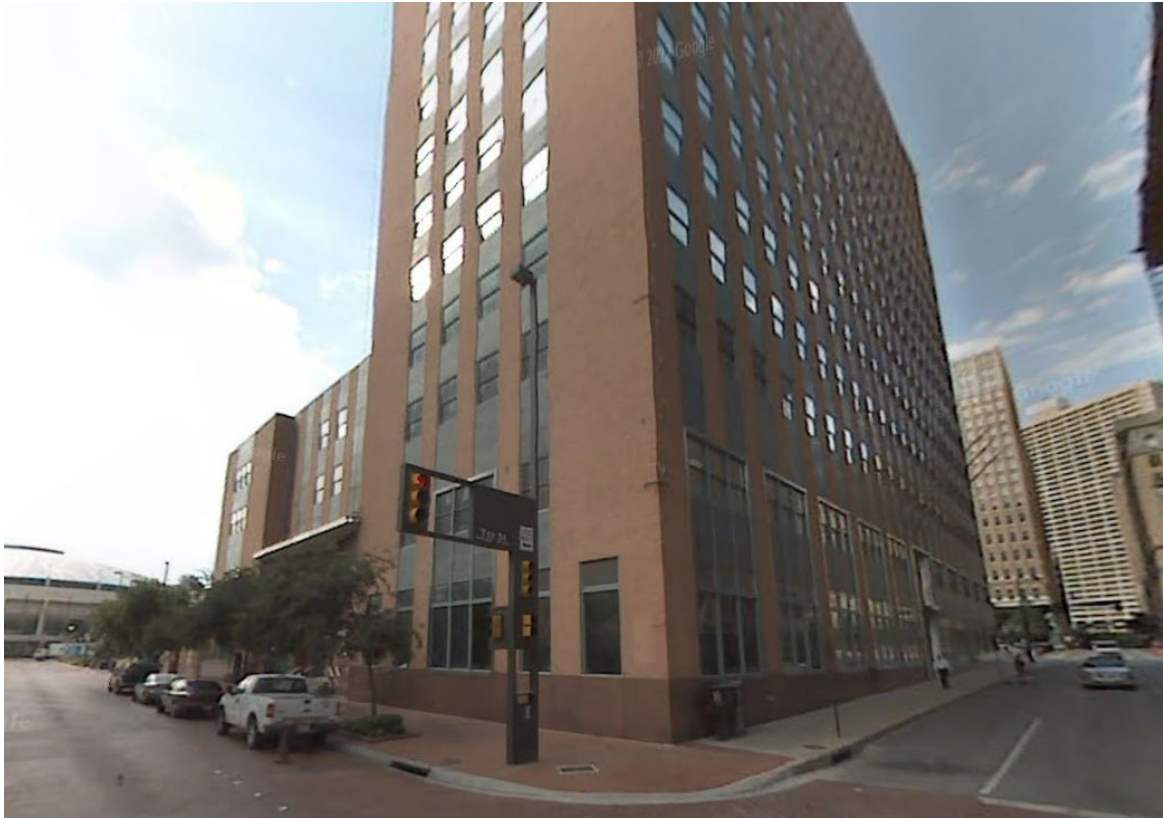
Figure 5 Google Street View of 115 W 7th St circa 2007 before the 2011 exterior renovations to the first and second floors. NEC at 7th and Main St.

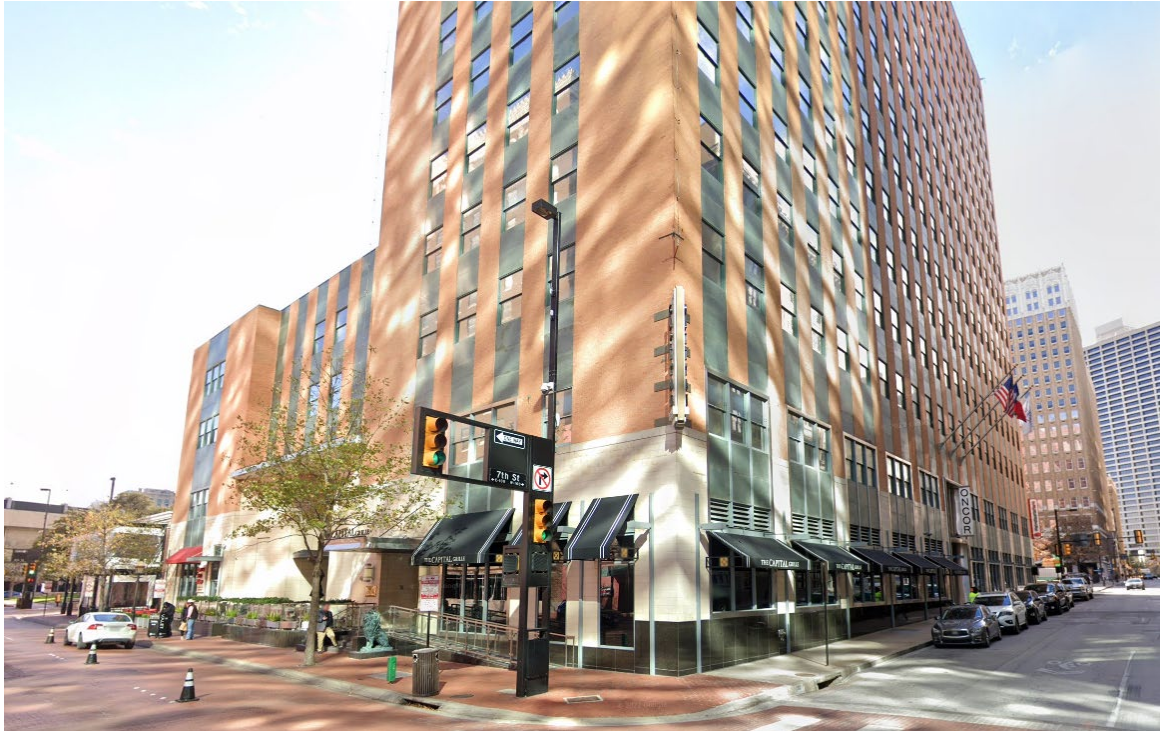
Figure 6 Google Street View of 115 W 7th St circa 2022 after the 2011 exterior renovations to the first and second floors. NWC at 7th and Houston. Note the awnings, Oncor signage, additional storefront windows, material changes, ramp and outdoor patio area for a restaurant tenant.

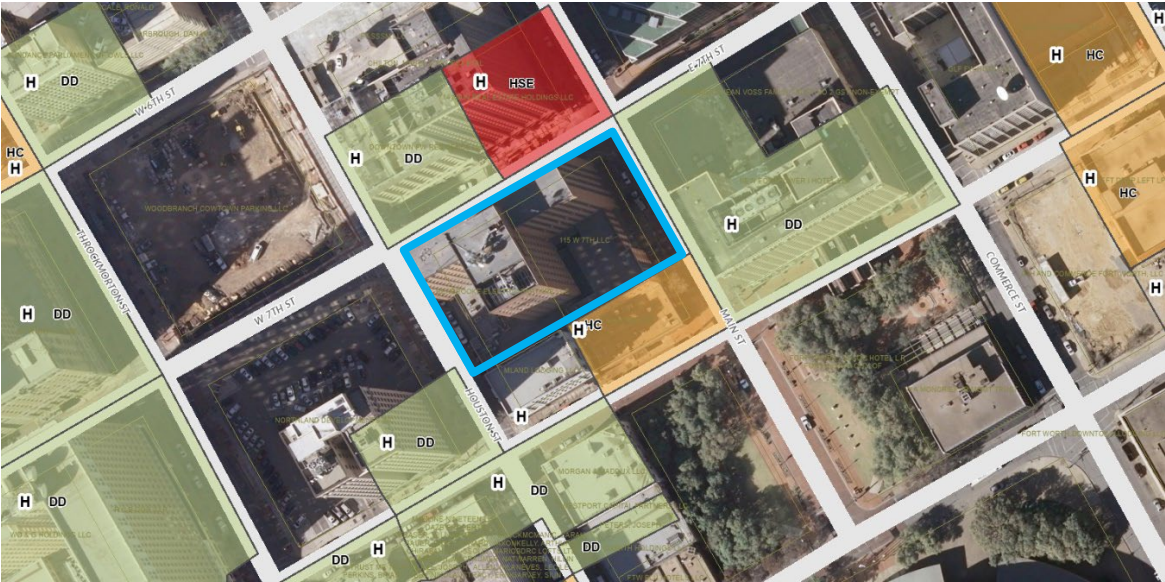
Figure 7 Aerial Image showing the historic context surrounding 115 W 7th St (outlined in blue) and adjacent buildings with designations ranging from Demolition Delay (DD), Historic and Cultural (HC), and Highly Significant and Endangered (HSE).

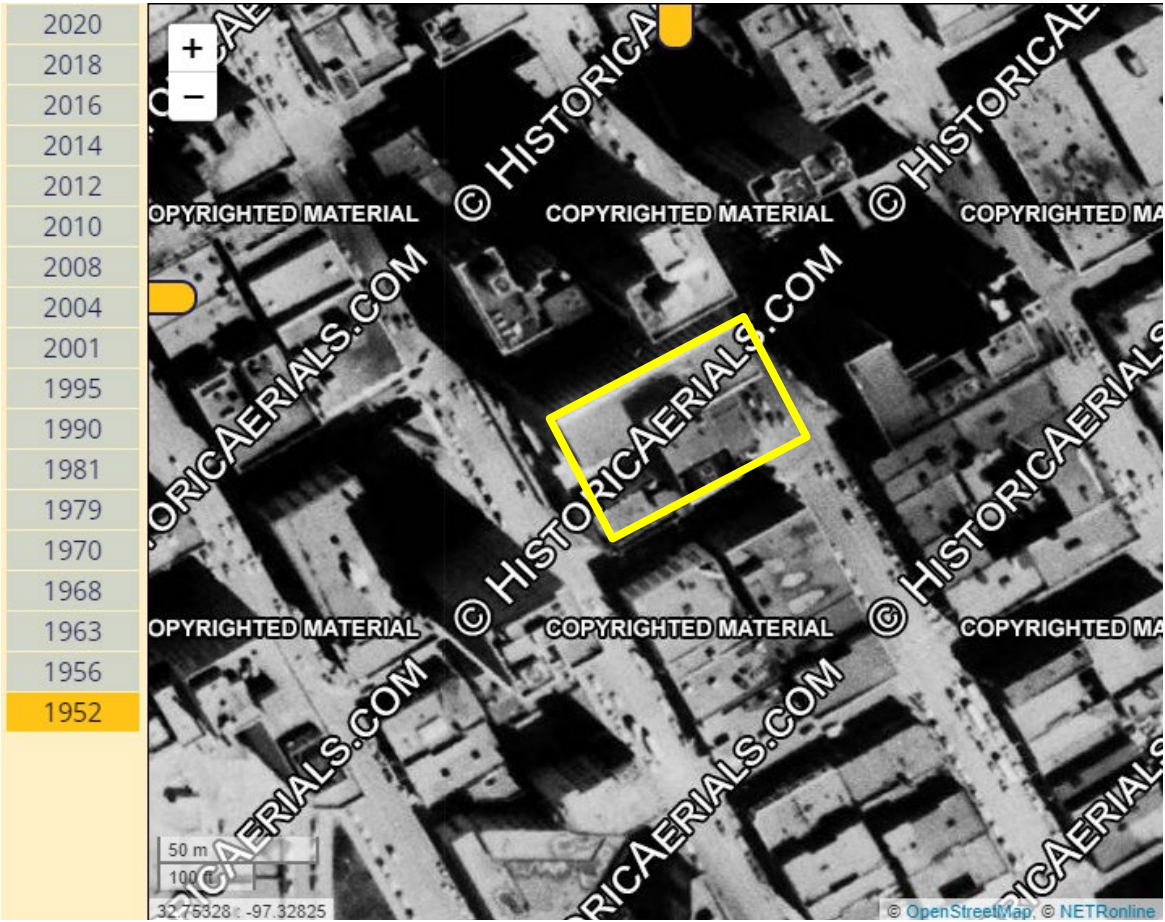
Figure 8 115 W 7th Street in 1952 (outlined in yellow)

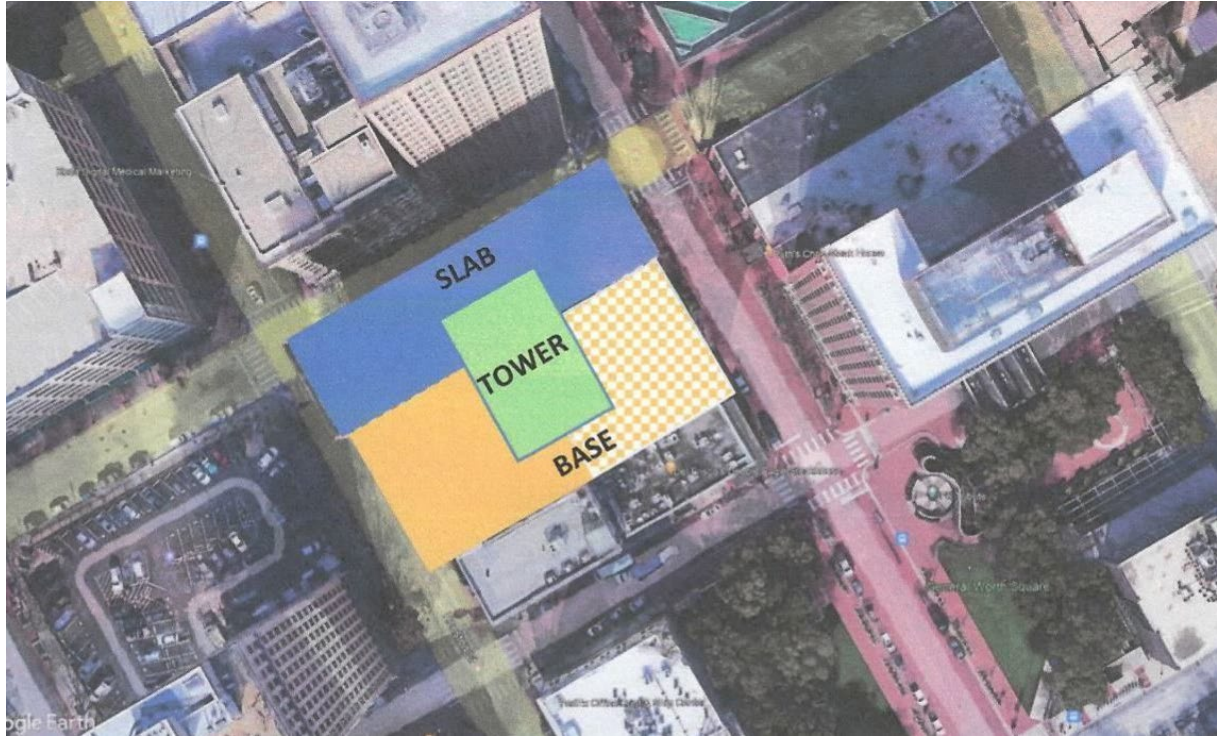
Figure 12 Delineation of the three segments of the building: slab, base, and tower. Checkered area of the base indicates the area where a fourth story and a small four-story addition were constructed in 1961. Google Earth Pro image, retrieved October 8, 2021.

In regards to Criterion 2, 115 W 7th Street is an example of a post-World War II Modernist skyscraper. The building is composed of three segments. The front section is a symmetrical fifteen-story slab that fronts West 7th Street. Behind the slab is a three- and four-story irregular rectangular-shaped base that fronts Main and Houston Streets. Historically, both the east and west elevations of the base were three stories tall. In 1961, a fourth floor was added on the base's east elevation and a small four-story addition was built at its southeast corner. Rising behind the center of the slab and setback from the base is a tower that rises to sixteen stories. The sixteenth floor of the tower rises above the roof of the fifteen-story slab and is referred to as the penthouse. The tower gives the building a T-shape above the base. The front slab and base feature rust-colored face brick curtain walls whereas the tower's curtain walls are built of a rust colored common brick. The building is largely unadorned although the grouping and alignment of windows and the contrasting color and texture of the Virginia greenstone spandrels on the front slab and base provide visual interest and are a character-defining feature. As with many mid- to high-rise buildings from the mid-twentieth century, its exterior is organized as a two-part vertical block with parapets that lack a cornice or other distinctive features. Instead, they are capped with stainless steel coping.

1. The building is still in its original **location** from when it was constructed in c. 1952.
2. The **design** of the T-shaped 16-story building is generally extant and identifiable. Historically, the base of the building was only three stories high on both the east (Main Street) and west (Houston Street) elevations but in 1961 a fourth floor was added on the east elevation as was a small four-story addition at its south end.

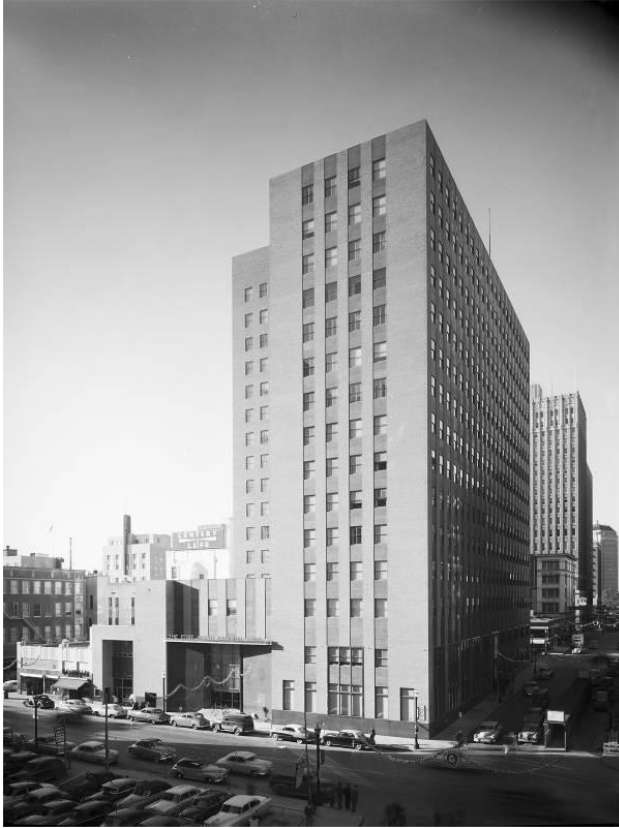
Figure 13 View Exterior of Fort Worth National Bank Building, 1952. East elevation, looking southwest. Courtesy, W. D. Smith Commercial Photography, Inc. Collection, Special Collections, The University of Texas at Arlington Libraries. AR430-52-3-29. Identifier 20097271.

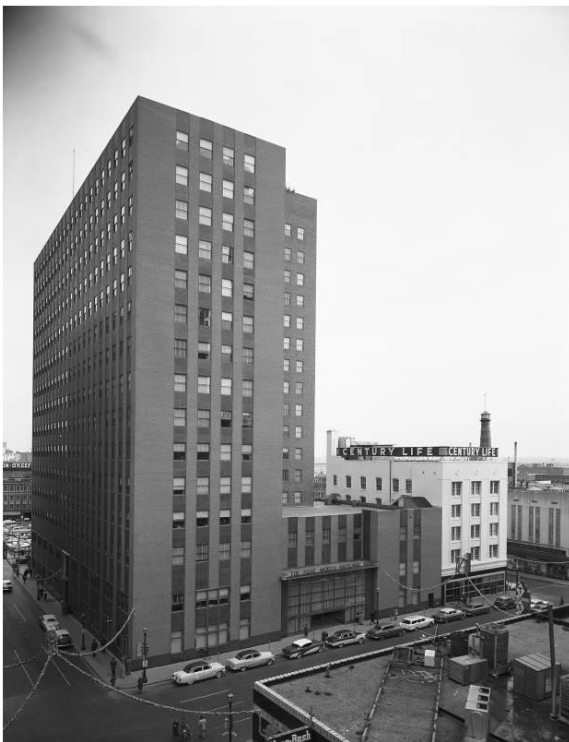
Figure 14 View Exterior of Fort Worth National Bank Building, 1952. East elevation, looking southwest. Courtesy, W. D. Smith Commercial Photography, Inc. Collection, Special Collections, The University of Texas at Arlington Libraries. AR430-52-3-29. Identifier 20097271.

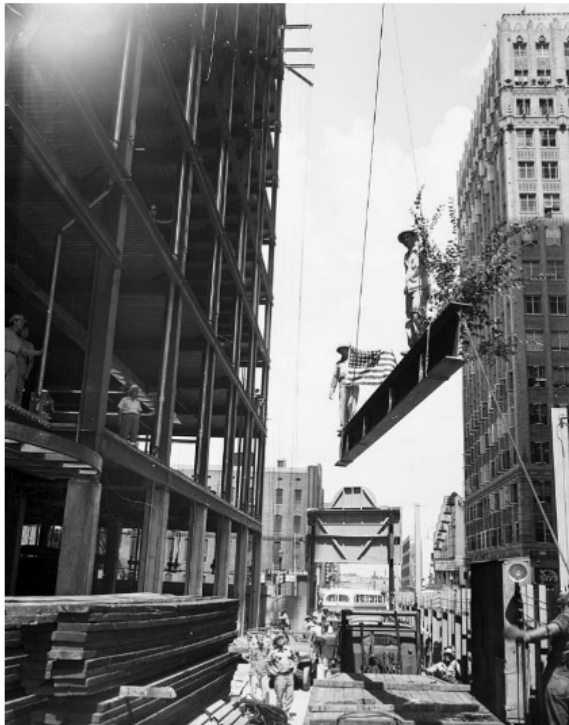
Figure 15 Fort Worth National Bank, 07/31/1951. H. Warren Smith, steel foreman, and Ed Grimes, inspector, ride the beam as the last piece of steel is hoisted into position atop the new Fort Worth National Bank Building. Courtesy, Fort Worth Star-Telegram Collection, Special Collections, The University of Texas at Arlington Libraries. AR406-6-457. Identifier 20126776.

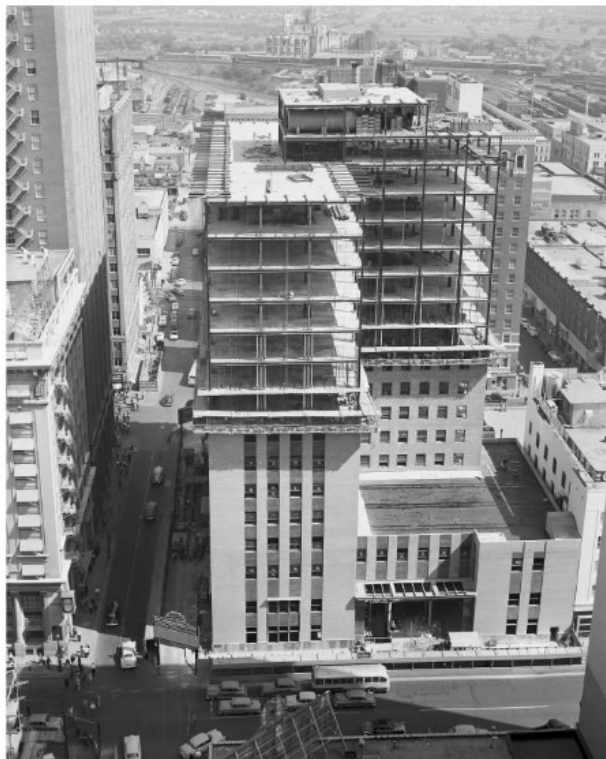
Figure 16 View Exterior of Fort Worth National Bank Building, 1952. East elevation, looking southwest. Courtesy, W. D. Smith Commercial Photography, Inc. Collection, Special Collections, The University of Texas at Arlington Libraries. AR430-52-3-29. Identifier 20097271.

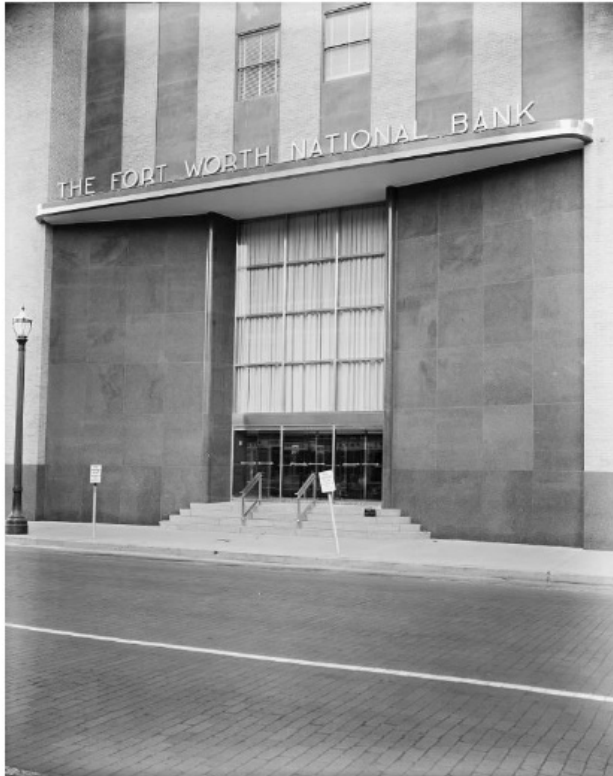
Figure 17 View Exterior of Fort Worth National Bank Building, 1952. East elevation, looking southwest. Courtesy, W. D. Smith Commercial Photography, Inc. Collection, Special Collections, The University of Texas at Arlington Libraries. AR430-52-3-29. Identifier 20097115.

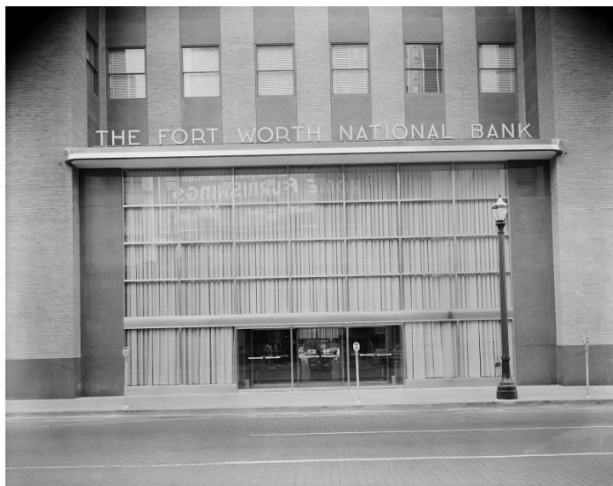
Figure 18 Exterior of Fort Worth National Bank Building, 1952. West elevation, Houston Street entrance, looking east. Courtesy, W. D. Smith Commercial Photography, Inc. Collection, Special Collections, The University of Texas at Arlington Libraries. AR430-52-592-13. Identifier 20097114.

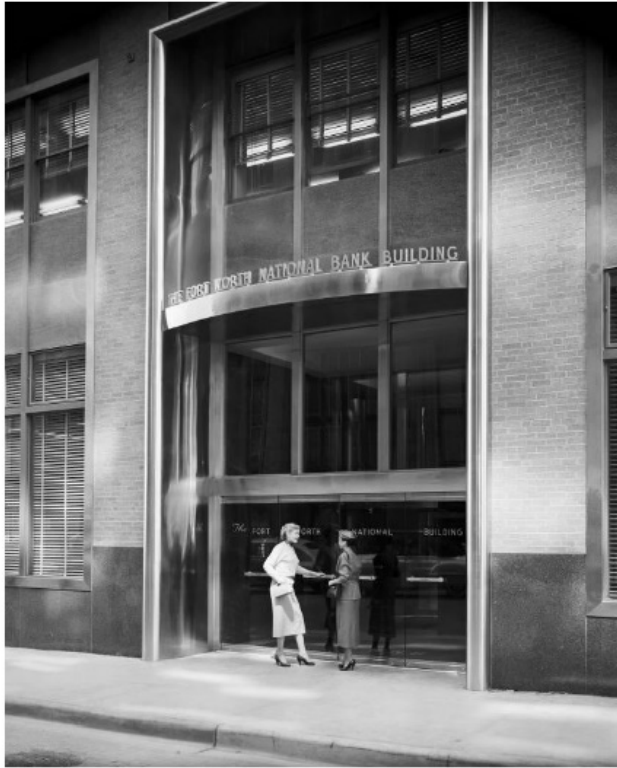
Figure 19 Two women entering Fort Worth National Bank Building, 1953. North elevation, West 7th Street entrance, looking southeast. Courtesy, W. D. Smith Commercial Photography, Inc. Collection, Special Collections, The University of Texas at Arlington Libraries. AR430-53-1-43. Identifier 20098421.

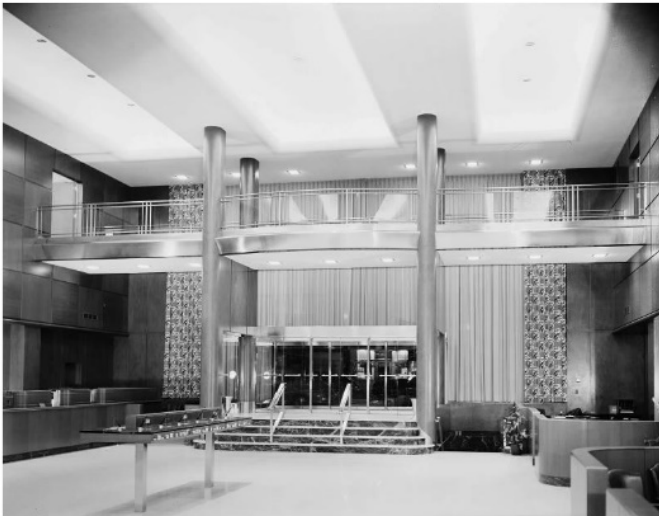
Figure 20 Interior of Fort Worth National Bank Building, 1952. Banking room, first floor, looking west. Courtesy, W. D. Smith Commercial Photography, Inc. Collection, Special Collections, The University of Texas at Arlington Libraries. AR430-52-592-11. Identifier 20096915.

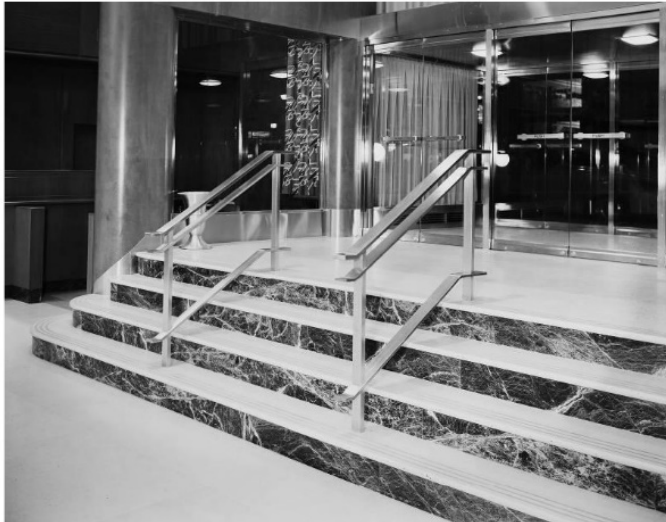
Figure 21 Interior of Fort Worth National Bank Building, 1952. Banking room, stairs at west (Houston Street) entrance, first floor, looking southwest. Courtesy, W. D. Smith Commercial Photography, Inc. Collection, Special Collections, The University of Texas at Arlington Libraries. AR430-52-592-9. Identifier 20096925.

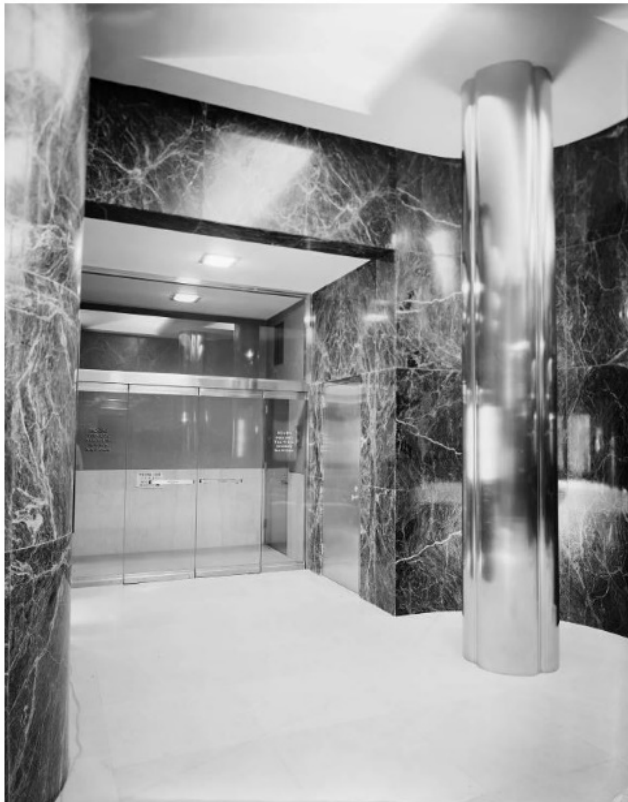
Figure 22 Interior of Fort Worth National Bank Building, 1952. Elevator lobby off of West 7th Street entrance, looking west/northwest. Courtesy, W. D. Smith Commercial Photography, Inc. Collection, Special Collections, The University of Texas at Arlington Libraries. AR430-52-592-10. Identifier 20096914.

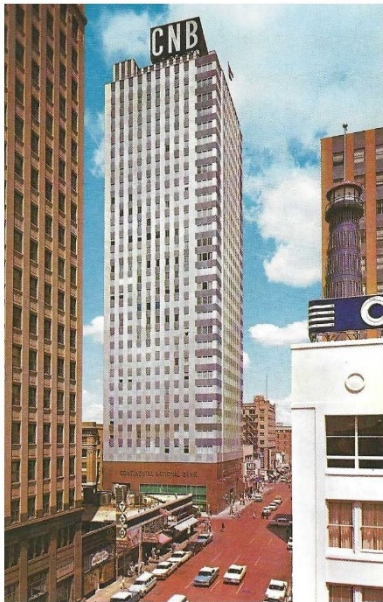
Figure 26 Continental National Bank Building, West 7th and Houston Streets. Designed by Preston M. Geren, Architect and Engineer (1952, 1956-57, demolished 2006). View looking north up Houston Street. Fort Worth National Bank Building is in the background, right side of the photograph. Strykers' Western Fotocolor, Artist Photographers, Fort Worth, Texas (authors' collection).

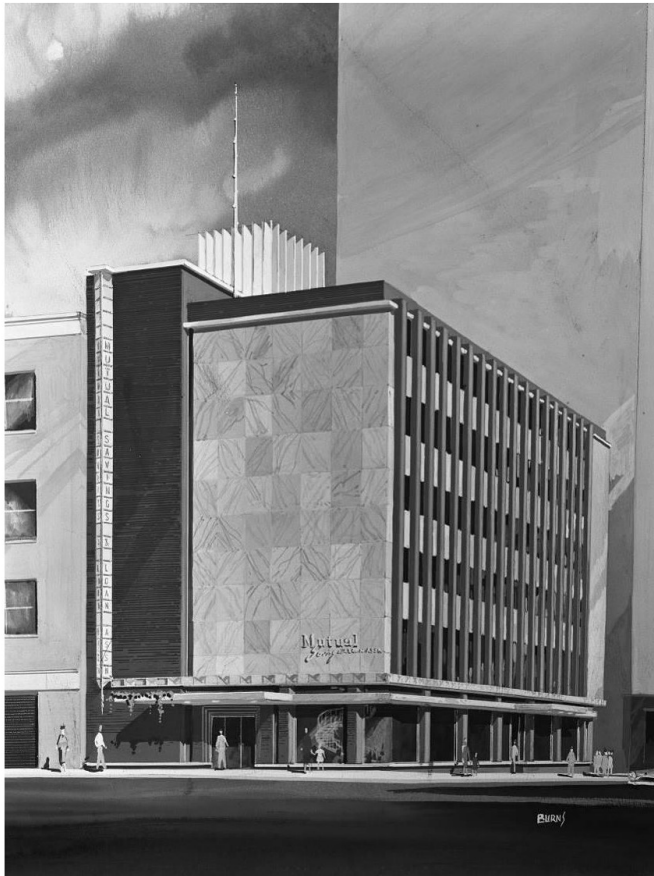
Figure 27 Rendering, c. 1957 of Mutual Savings and Loan Building, West 8th and Throckmorton Streets. Designed by Preston M. Geren, Architect and Engineer (1958, demolished 1998). View looking northeast. Courtesy, W. D. Smith Commercial Photography, Inc. Collection, Special Collections, The University of Texas at Arlington Libraries. AR430-57-224-8. Identifier 20101524.
